TS-AMD-87615-25  
May 1988

AERIAL PHOTOGRAPHIC ANALYSIS OF THE REFINED METALS CORP.

Indianapolis, Indiana

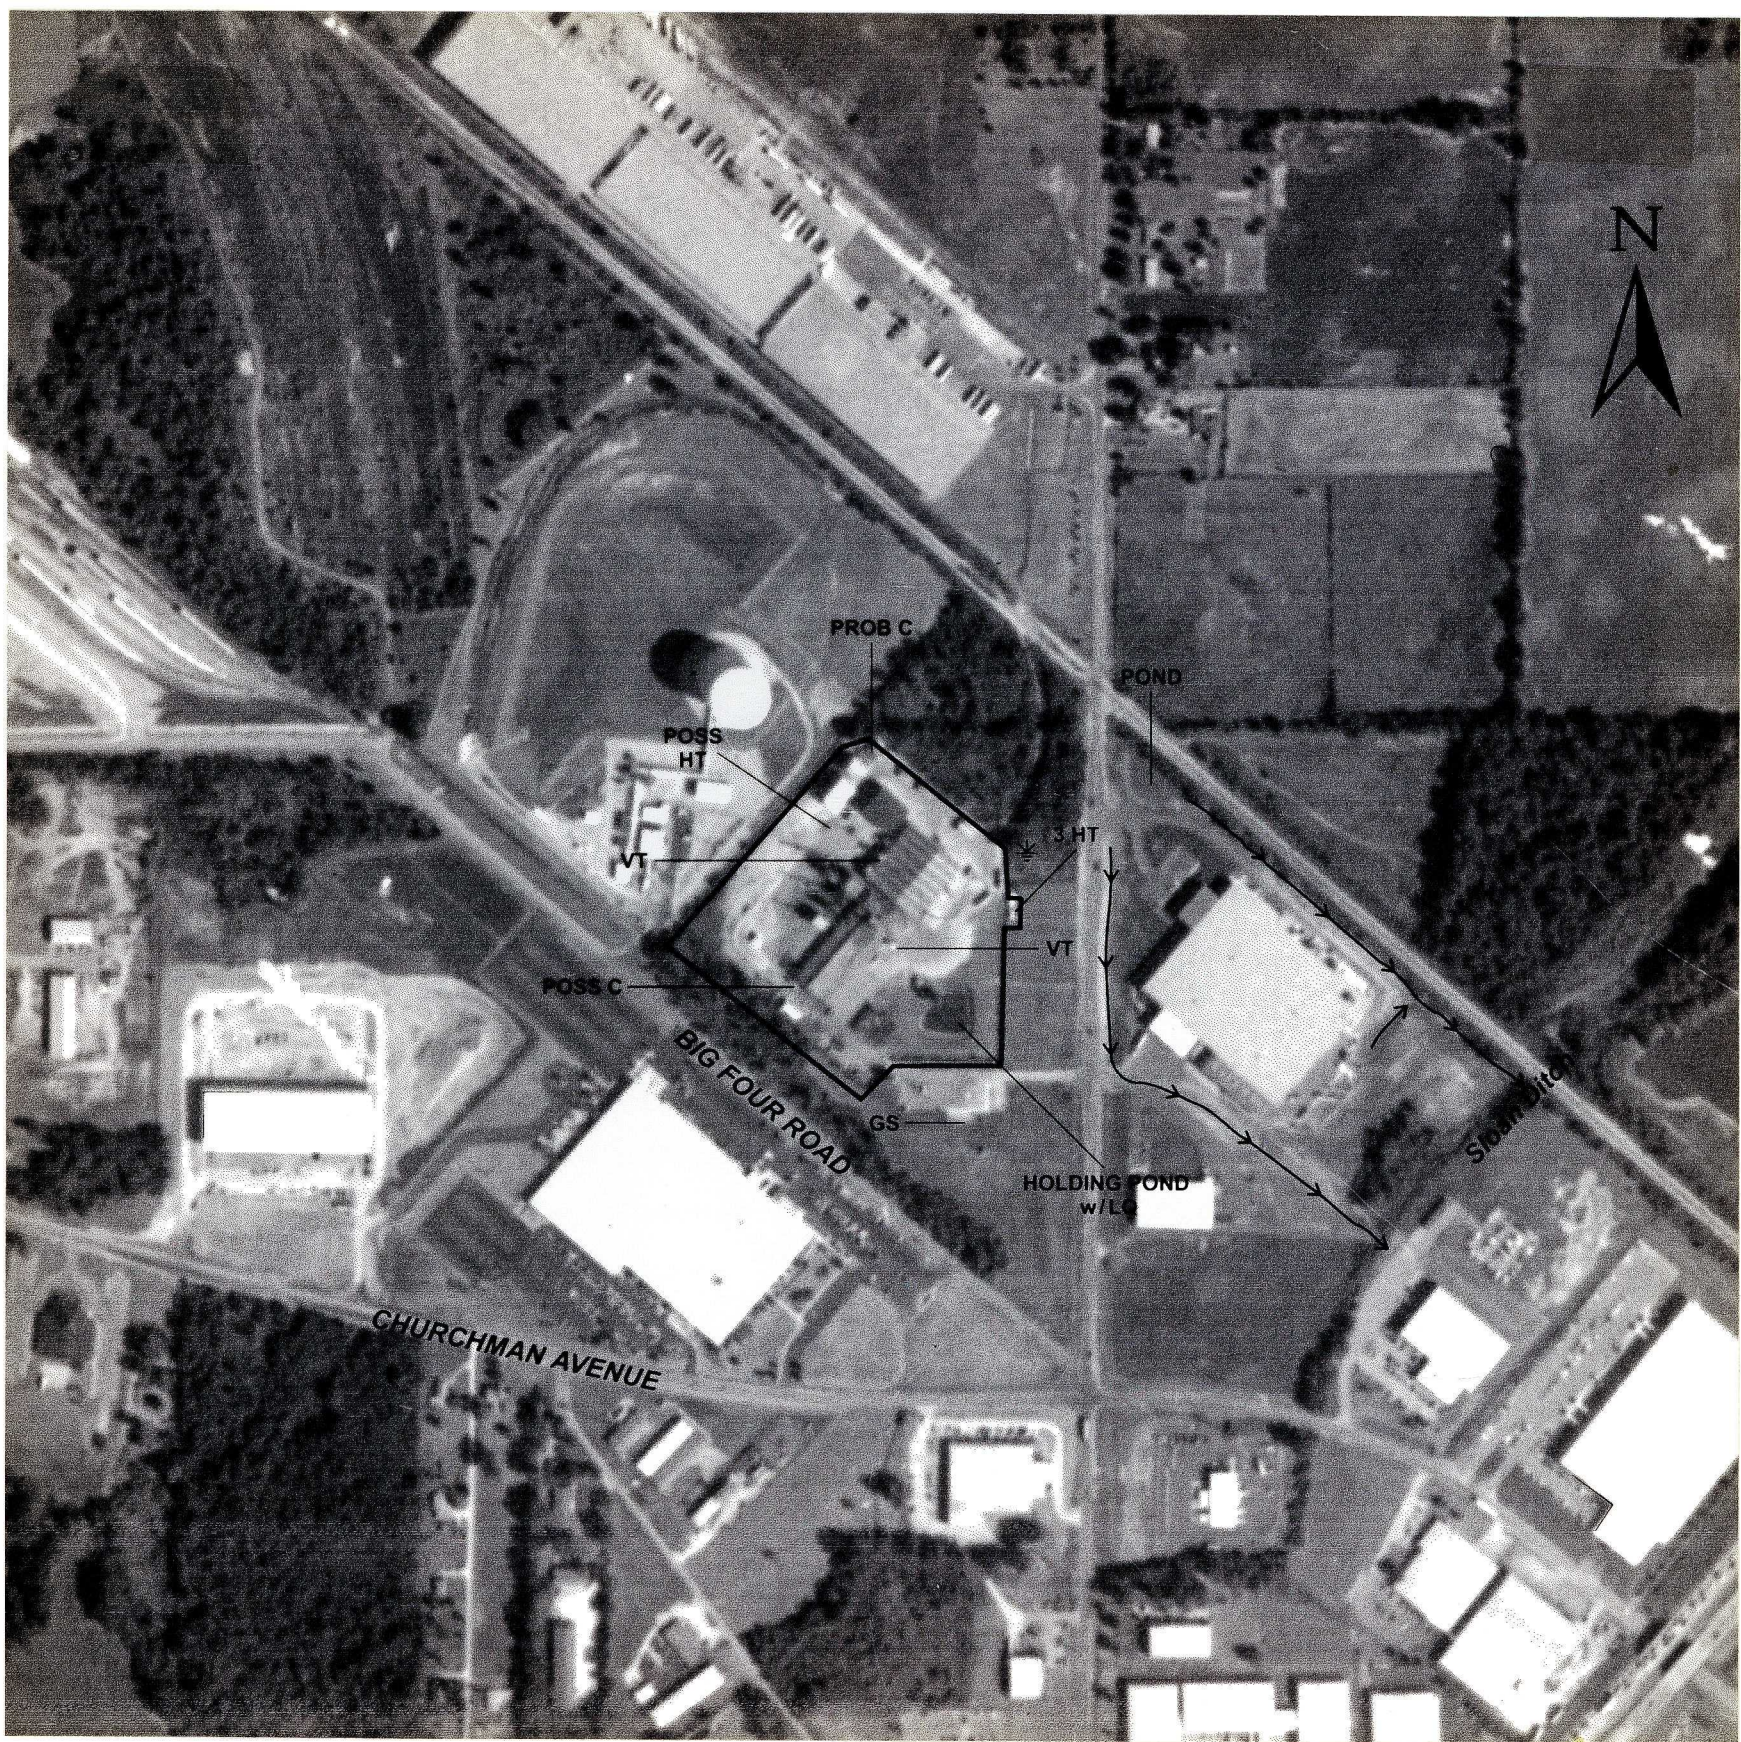
FIGURE 6  
REFINED METALS CORPORATION

**June 21, 1989 (FIGURE 5)**

Staining remains visible near buildings in the northwestern portion of the site. Areas of probable staining are also visible in the northeast and southwest portions of the site. A new building (NB) is visible in the northern portion of the site where light-toned mounded material was observed in 1986. South of the new building a possible horizontal tank is visible. A structure (S), appearing to be related to production activities is visible near the center of the site where medium-toned mounded material was seen in 1986. A large vertical tank (VT) is visible alongside a building (not annotated) near the center of the site. Several containers (C) are visible in the southwest portion of the site. In the southeastern portion of the site the holding pond with liquid remains. Southeast of the Refined Metals Corporation site an area of ground scarring (GS) is visible.

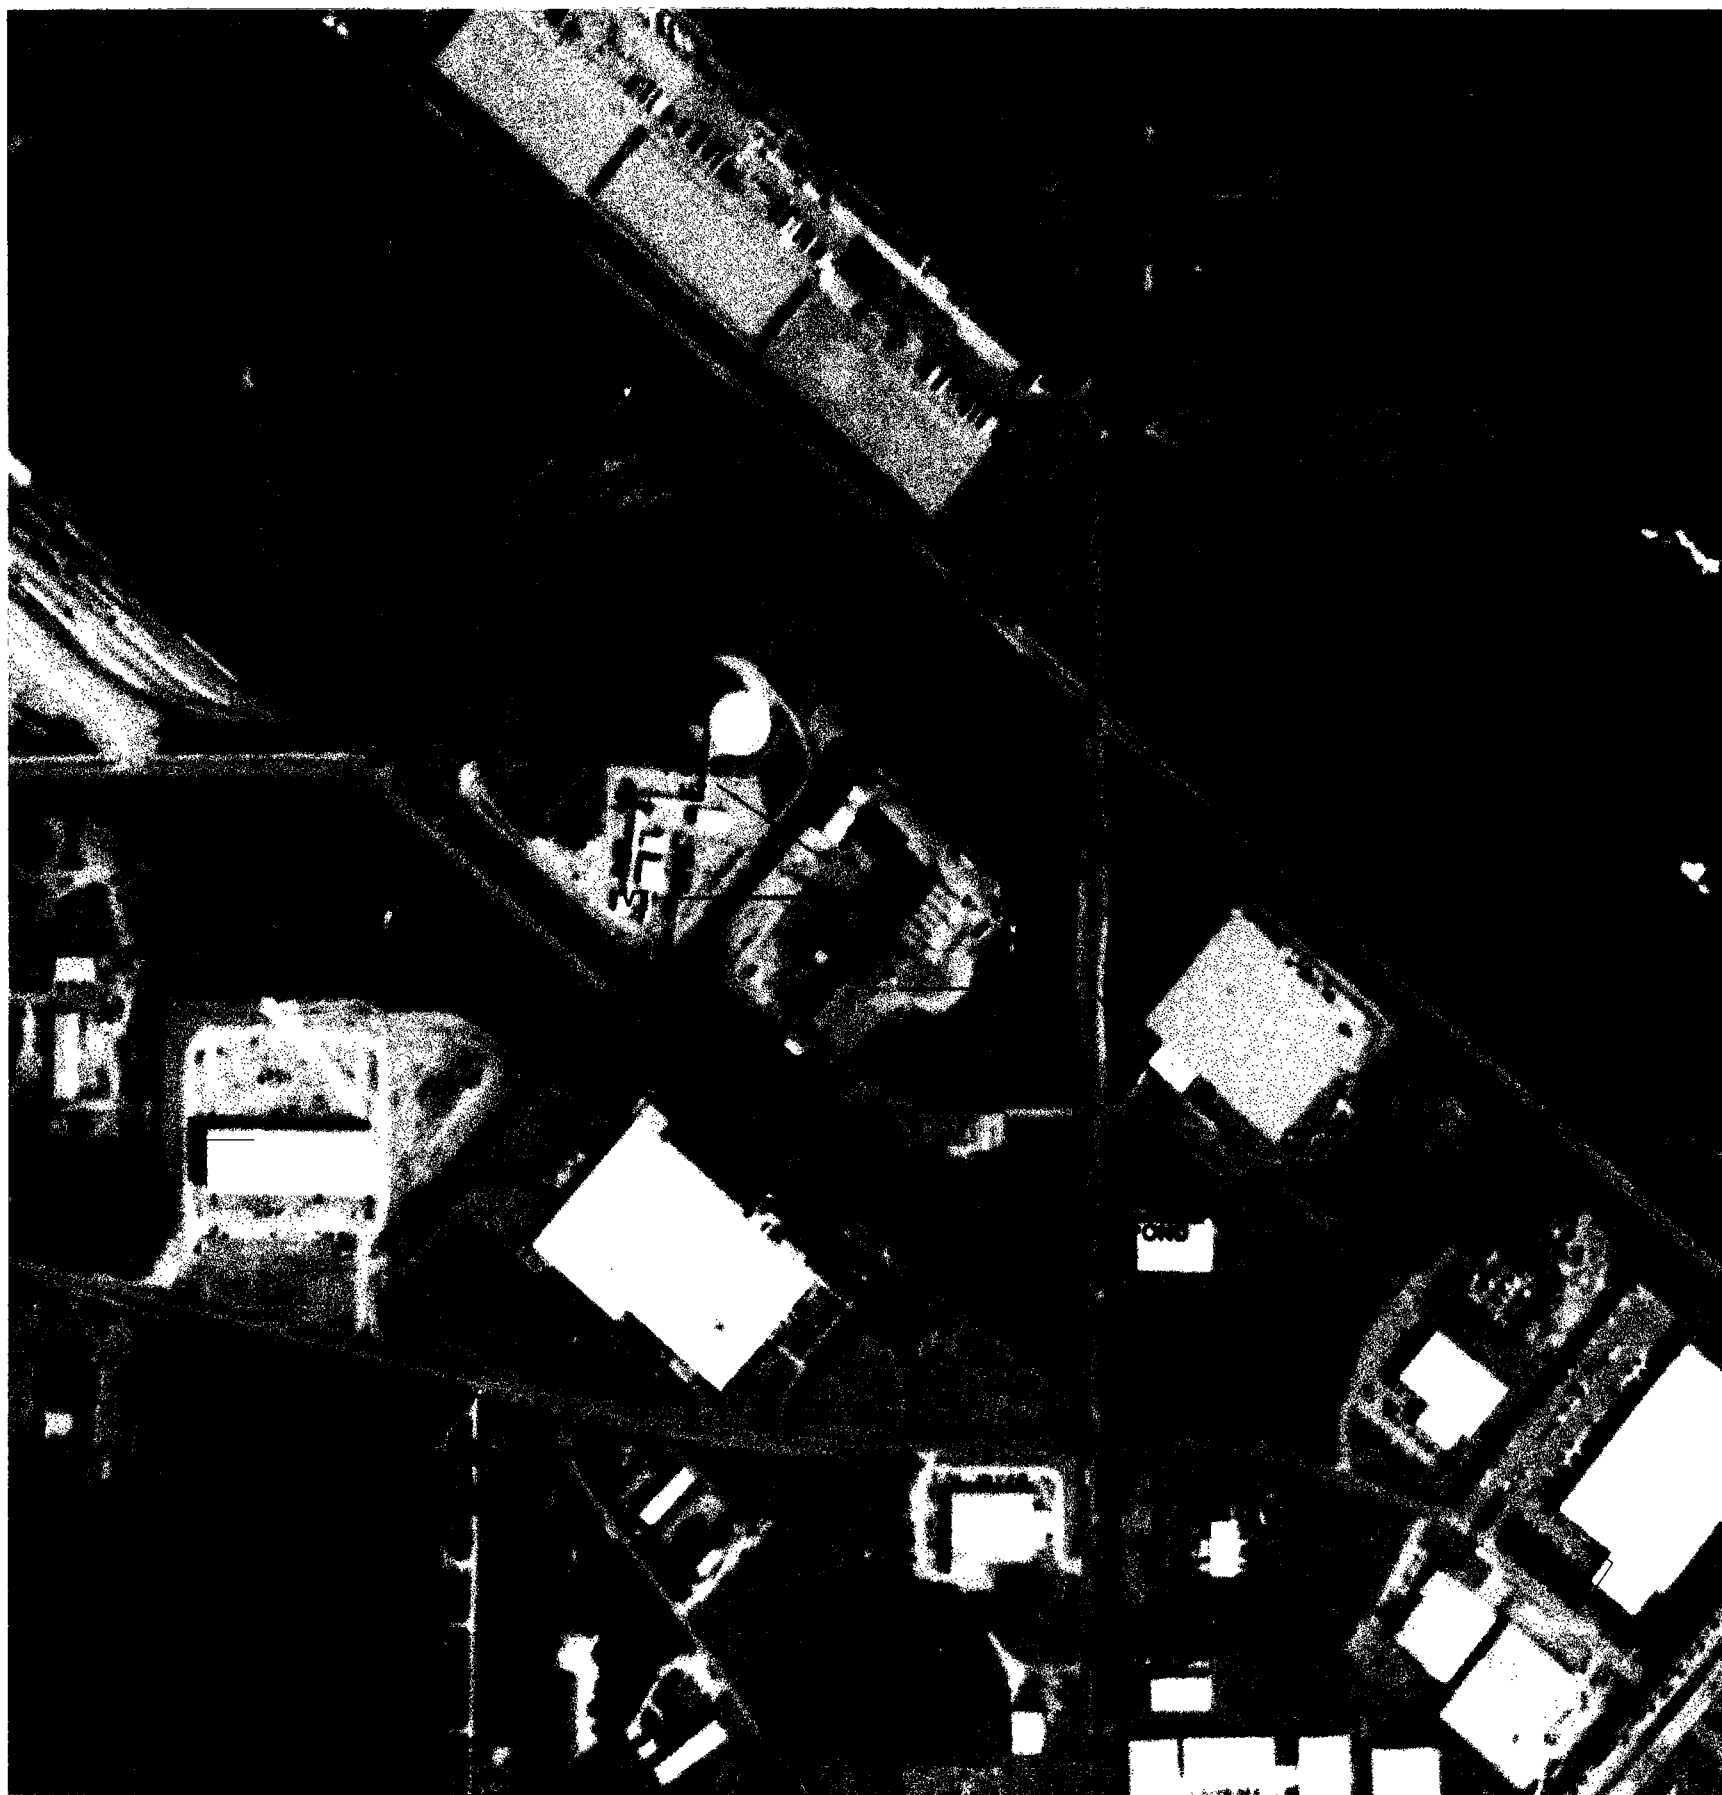
FIGURE 6  
REFINED METALS CORPORATION

A pond, excavated since 1989, is visible northeast of the Refined Metals Corporation site. A new (or reworked) channelized drainage leads southeast from the pond and flows into Sloan Ditch. Southwest of the aforementioned drainage an additional new channelized drainage is visible. This drainage also flows into Sloan Ditch. Outside the northeast corner of the site, where two small wetlands were visible in 1989, one contiguous wetland is now visible.

The probable stain and stain seen in the northern portion of the site in 1989 are no longer visible. The possible horizontal tank seen in the northern portion of the site remains. Nearby, a large vertical tank is visible alongside a building (not annotated). The large vertical tank, first seen in 1989, remains near the center of the site. The containers seen in the southern portion of the site in 1989 are no longer visible. Also in the southern portion of the site, an area of possible containers is visible alongside a building (not annotated). The probable stain seen in the southwest portion of the site in 1989 is no longer visible. The holding pond with liquid remains in the southeast portion of the site. Southeast of the Refined Metals Corporation site the area of ground scarring remains.

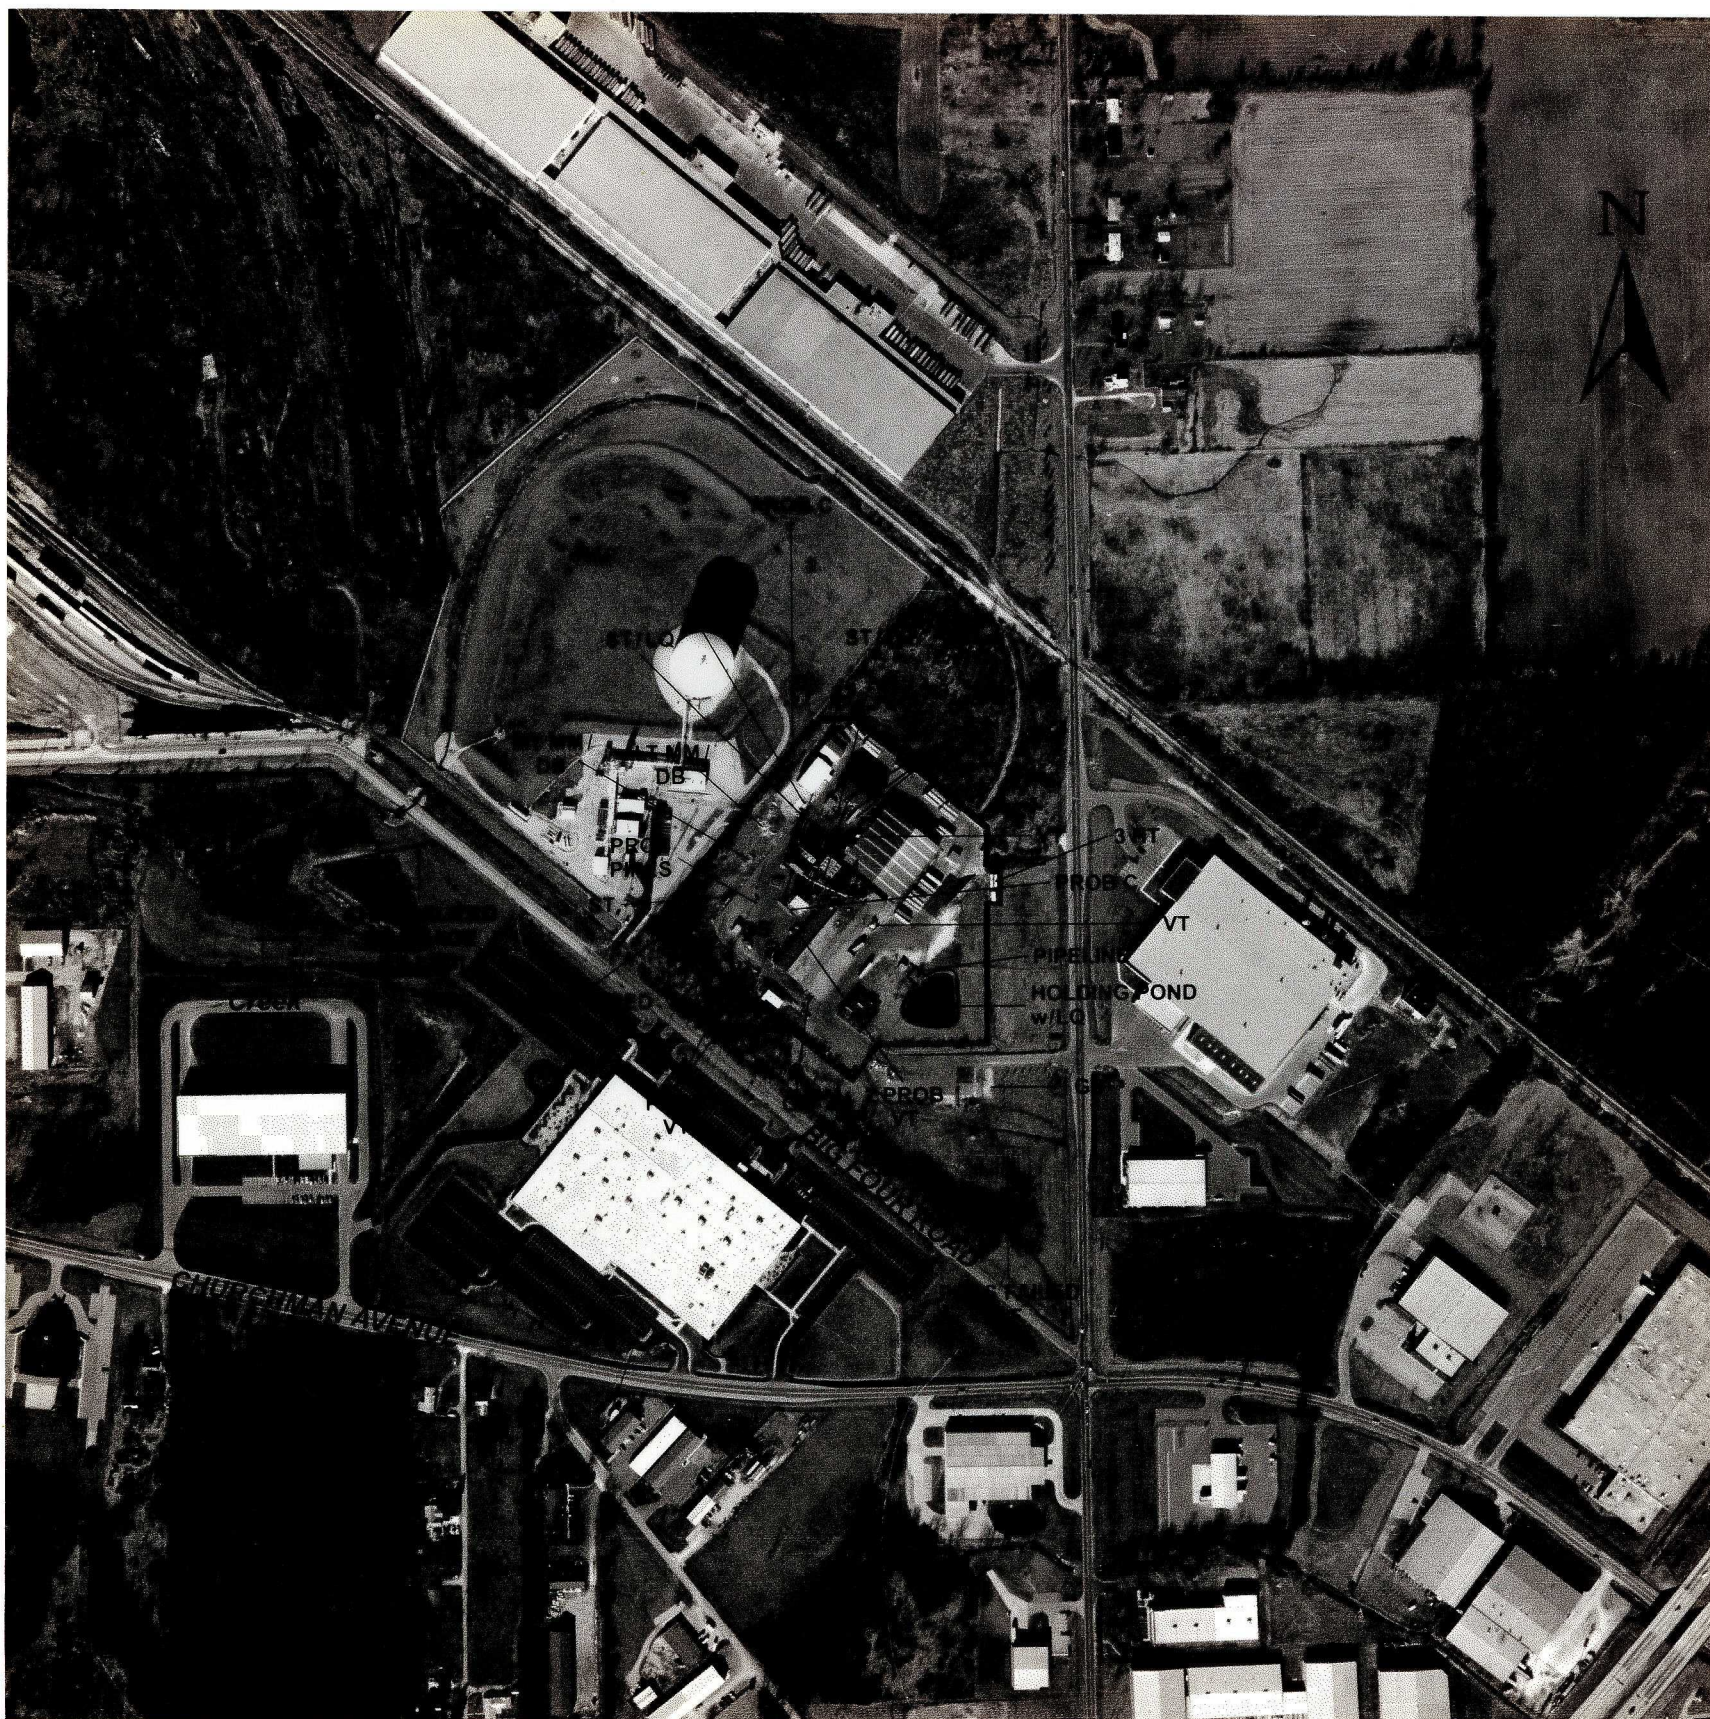
FIGURE 7  
REFINED METALS CORPORATION

A large horizontal tank, surrounded by a probable fence (not annotated), is visible in the northwest portion of the site. A possible horizontal tank was noted in this location in 1991. A stain or liquid emanates from within the fenced area. Two concentrations of containers are visible east of the horizontal tank. Staining or liquid is visible near the westernmost area of containers. Immediately south of the containers a new vertical tank is visible. An area of light-toned mounded material and debris (DB) and an area of medium-toned mounded material or debris are visible in the northwest portion of the site. A stain is visible next to a large piece of equipment (not annotated) in the west central portion of the site. East of this stain, probable pipes are visible extending north from a small structure (not annotated). In the center of the facility rows of large probable containers are visible. To the east, the large vertical tank first seen in 1991 remains.

In the west central portion of the site an area of open storage containing varying sized (possibly metal) objects (not annotated), and four probable vertical tanks (not annotated) is seen. Scattered objects are visible in the western portion of the open storage area. An open storage area containing scattered objects (not annotated) is visible in the south central portion of the site. In the southeast corner of the site two pipelines are

visible leading to the holding pond. These pipelines will continue to be annotated, but no longer discussed for the remainder of the analysis. Southeast of the site the ground scar seen in 1991 appears vegetated and will not be annotated or discussed in the future. South of the site a possible failing leach field is visible.

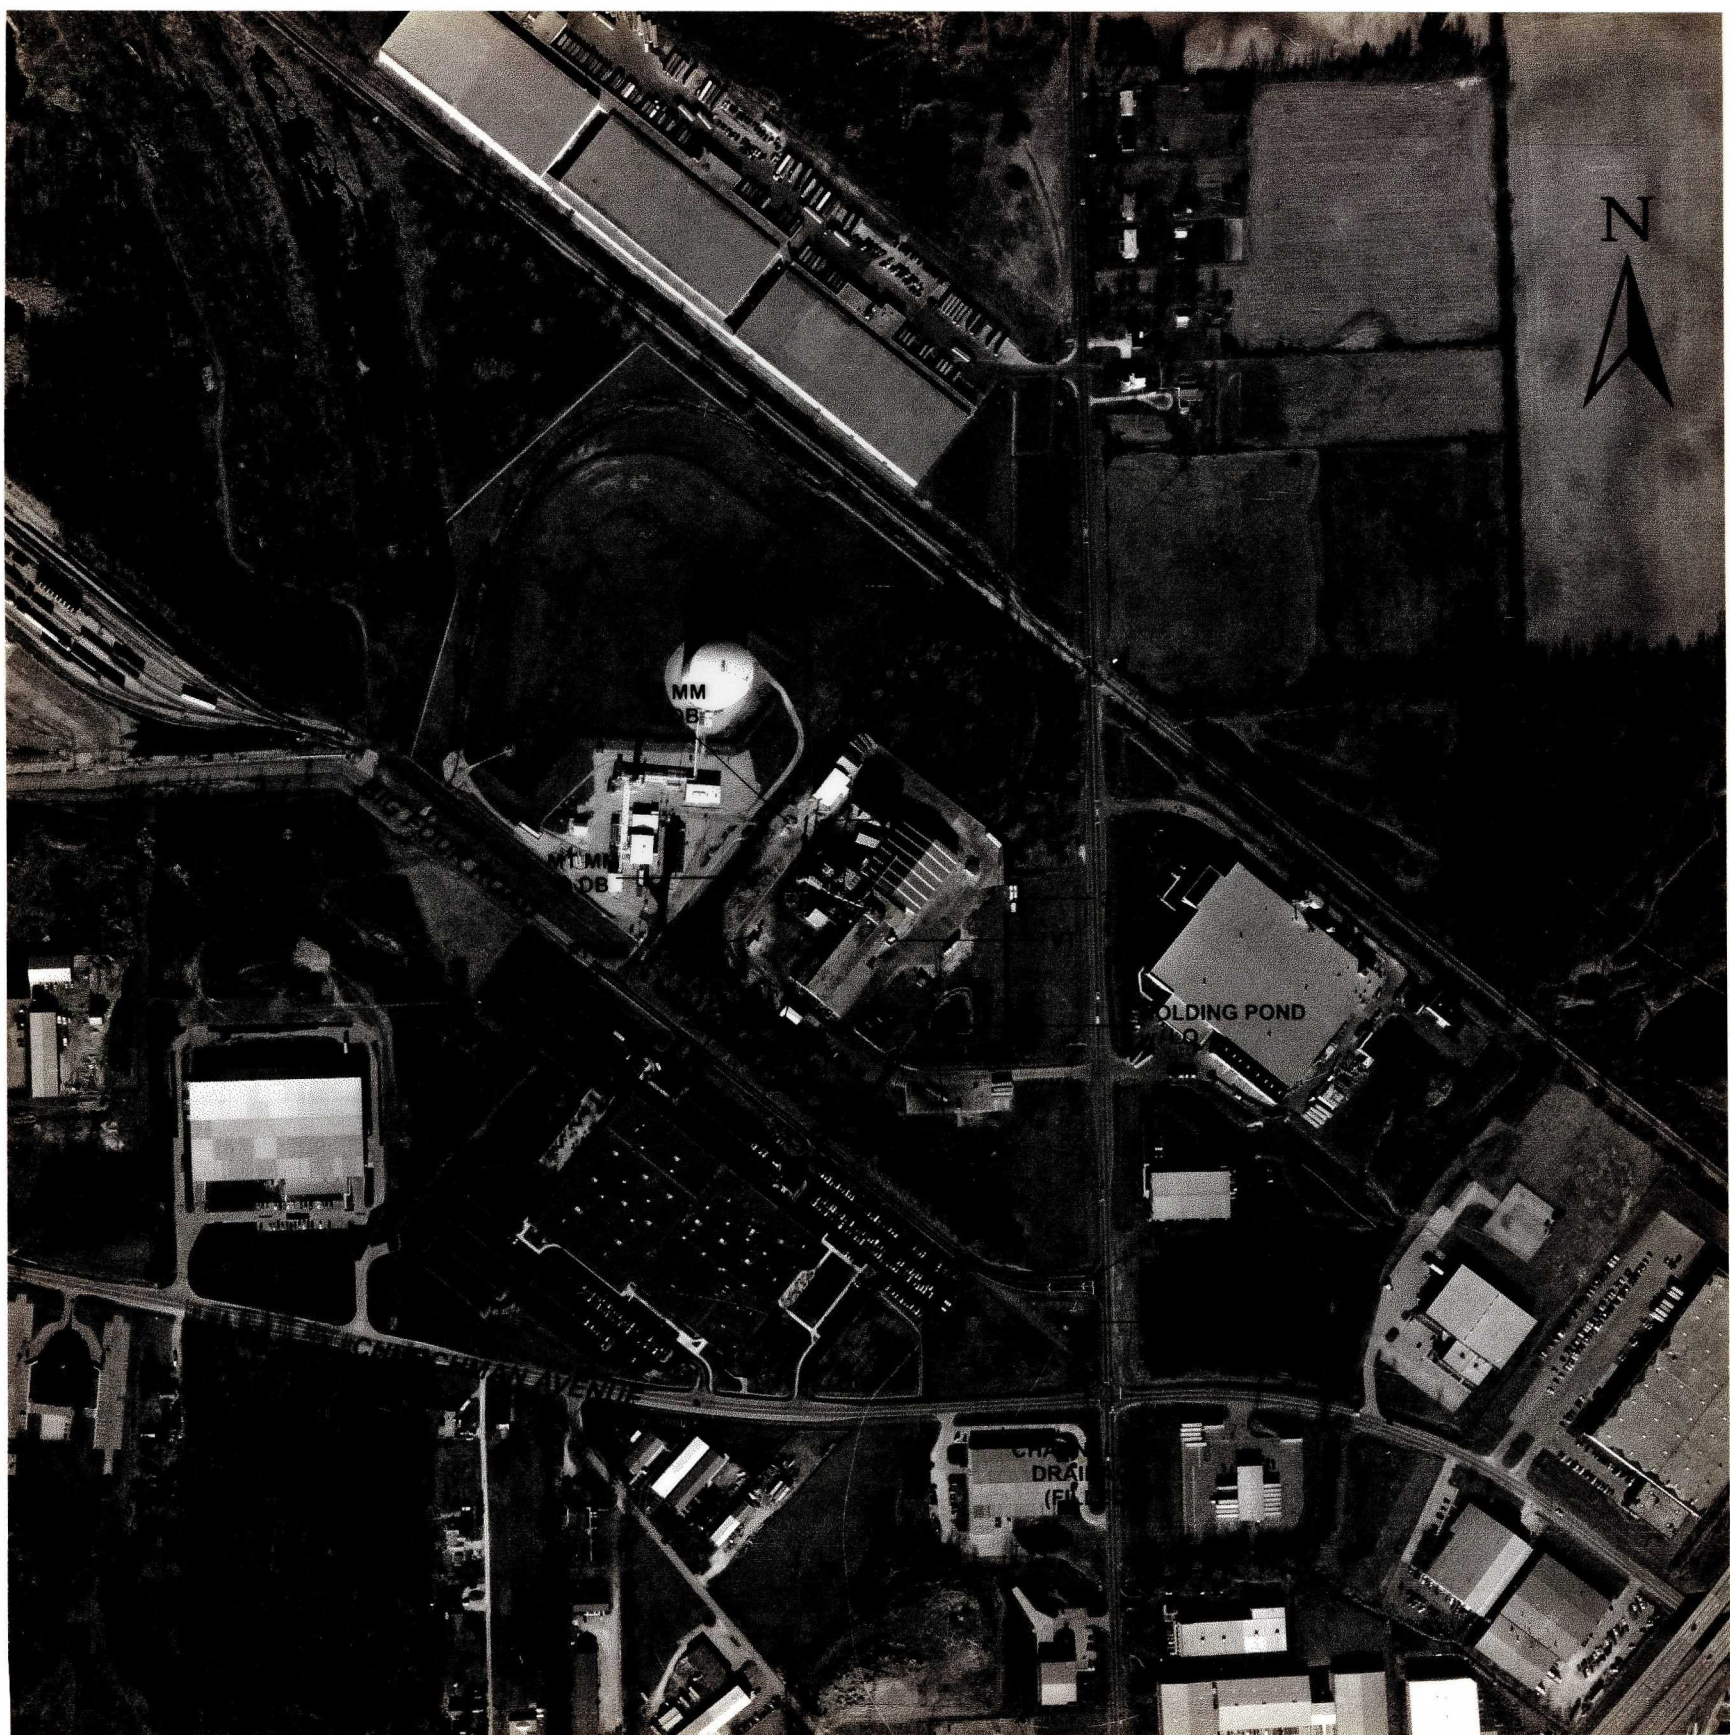
FIGURE 8  
REFINED METALS CORPORATION

The large horizontal tank seen in the northwest corner of the site remains. The stain or liquid that was seen near the horizontal tank in 1993 is no longer visible. The stain or liquid, stored containers, and large vertical tank located in the northern portion of the site in 1993 are no longer visible. The area of light-toned mounded material and debris, located in the northwest portion of the site, has increased in size since 1993. An area of medium-toned mounded material and debris, first seen in 1993, in the western portion of the site remains. The rows of large probable containers, located near the center of the site in 1993, are no longer visible. The large vertical tank, also located near the center of the site, remains.

Six probable vertical tanks are visible in the southwest portion of the site. The stain seen in the southwest corner of the site in 1993 is no longer visible. The scattered objects, present along the southern border of the site in 1993, are no longer visible. An open storage area remains visible near the south central portion of the site. The holding pond with liquid remains visible in the southeast portion of the site. No signatures are detected in this year's photograph of the possible failing leach field seen southeast of the site in 1993.

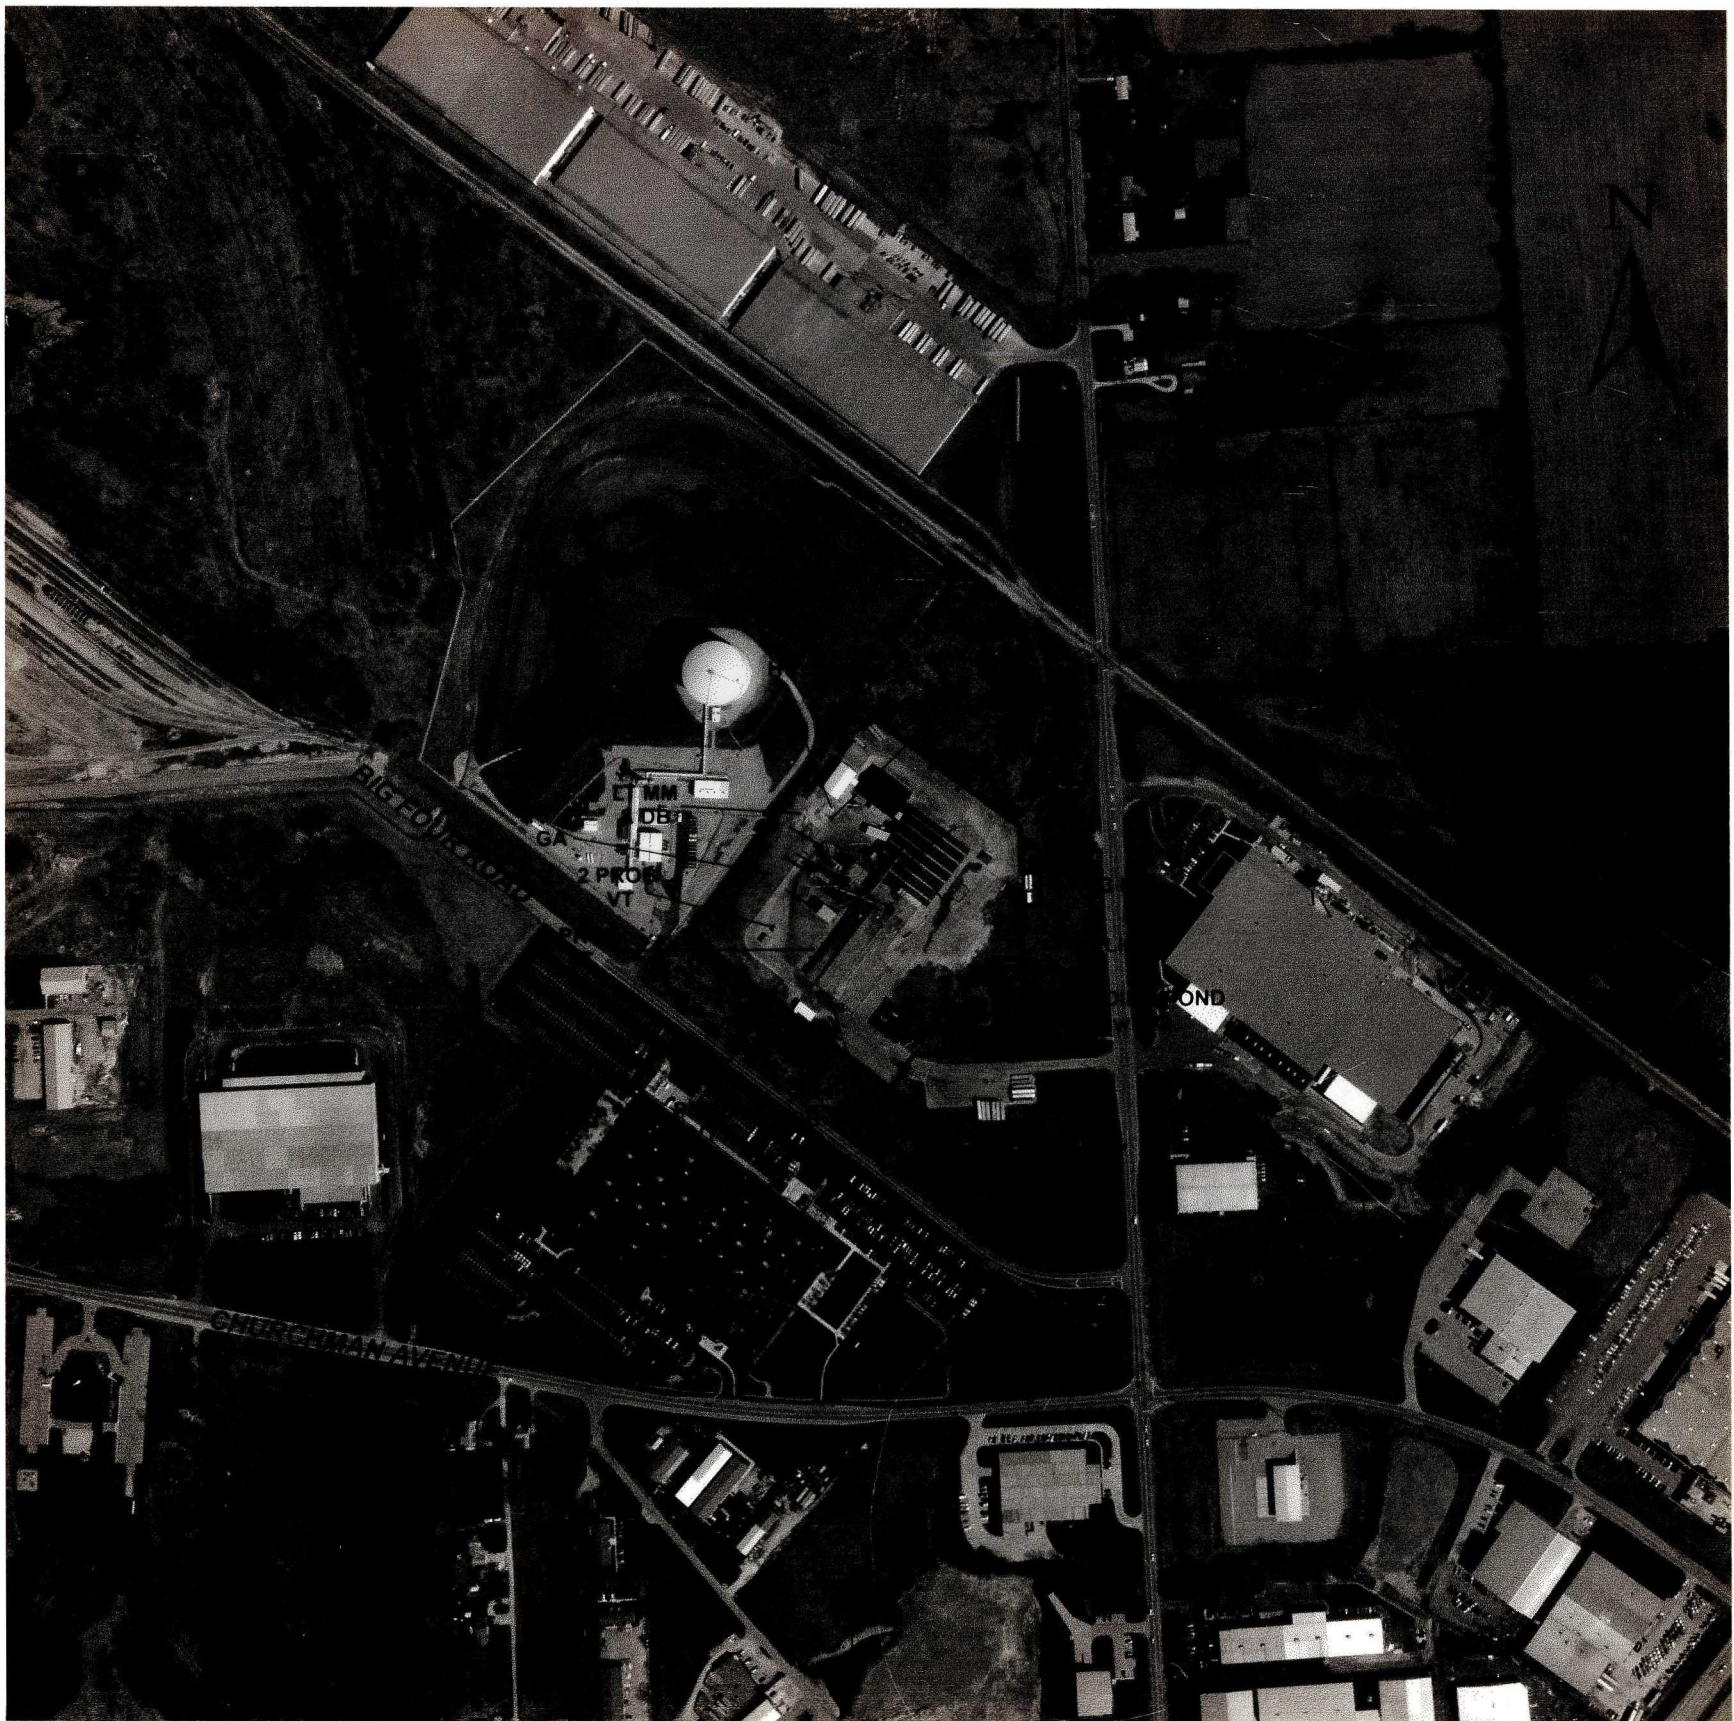
FIGURE 9  
REFINED METALS CORPORATION

The large horizontal tank located in the northern portion of the site remains. A stain emanates from the location of the horizontal tank. Adjacent to the tank the light-toned mounded material and debris remain. Two areas of liquid are visible near the edge of a large building (not annotated) in the northeast portion of the site. In the western portion of the site a graded area (not annotated) covered by vegetation is visible where medium-toned mounded material and debris were noted in 1995. The large vertical tank, seen alongside a building (not annotated) near the center of the site in 1995, is no longer visible. Six probable vertical tanks remain visible in the south central portion of the site.

A domed structure (DS) is the only remaining feature in the open storage (not annotated) area located in the south central portion of the site. South of the domed structure a probable stain or liquid is visible next to a vehicle (not annotated). In the southeast corner of the site the holding pond with liquid remains.

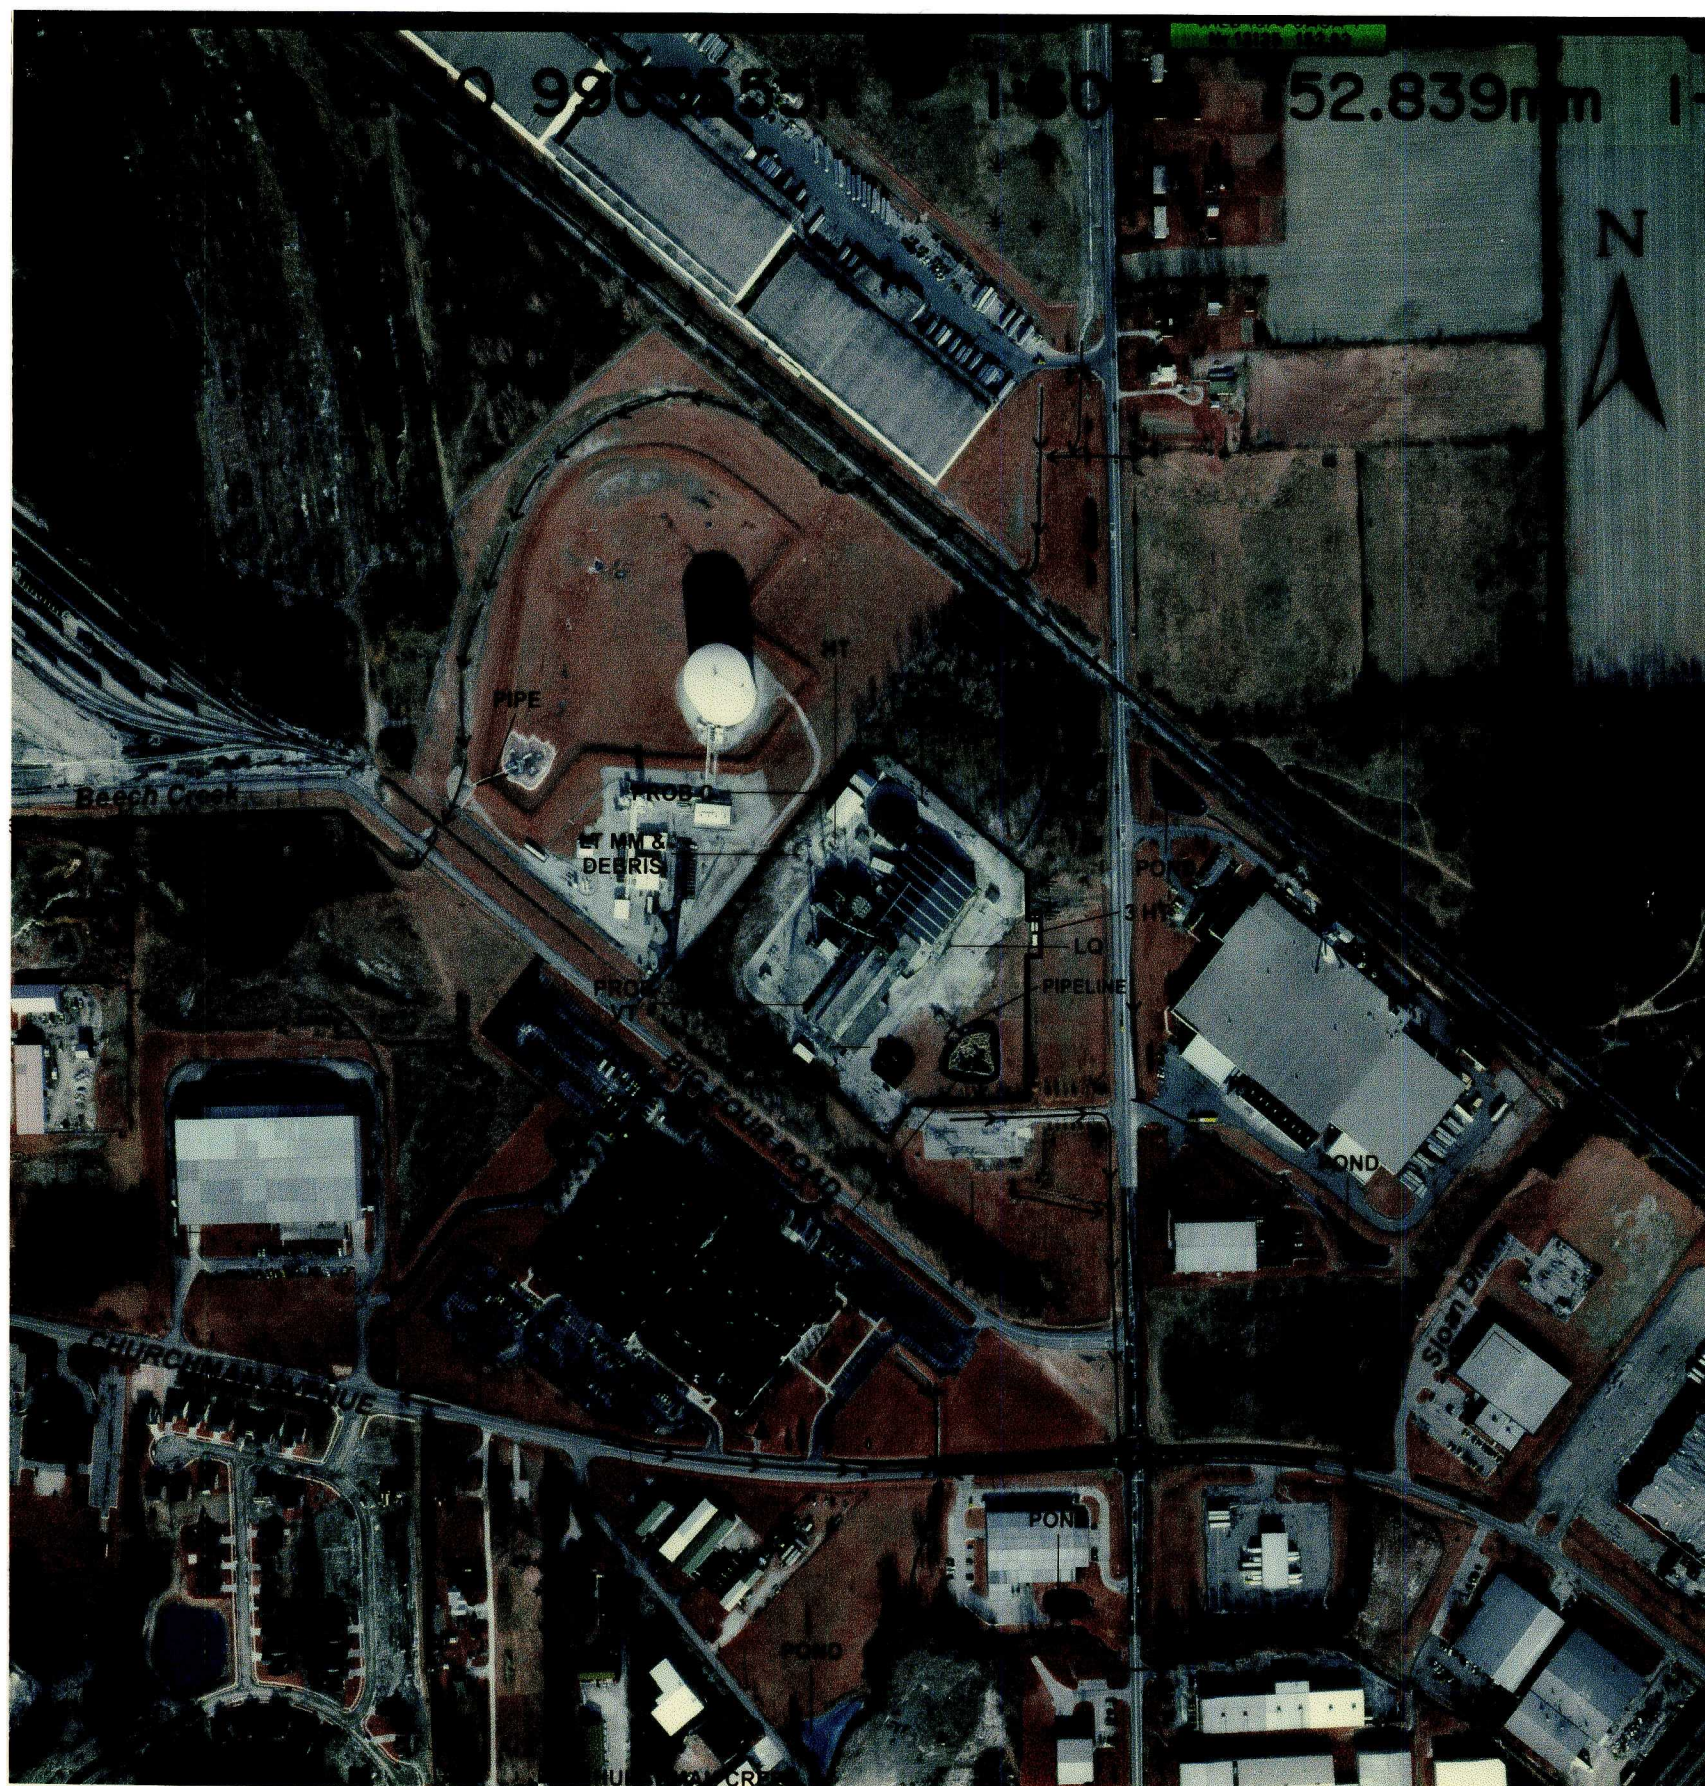
FIGURE 10  
REFINED METALS CORPORATION

South of Big Four Road, Beech Creek has been rerouted by filling and the excavation of a new channelized drainage. Immediately to the east only one of the two channelized drainages that flowed west towards Beech Creek is visible in this year's photograph. No aboveground connection is visible between this drainage and Beech Creek.

Northeast of the Refined Metals Corporation site a new pond is visible. A new (or reworked) channelized drainage flows southeast from this pond into Sloan Ditch. South of the aforementioned drainage an additional channelized drainage flowing south and east into a pond is visible. This pond also appears to drain into Sloan Ditch. On the eastern edge of the site one wetland is visible where two smaller ones were seen in 1985. The holding pond onsite contains wetland vegetation (VEG). Channelized drainages flow east and south from the vicinity of the holding pond. A portion of a channelized drainage and a portion of a wetland have been filled north of Churchman Avenue. The channelized drainage continues south from the remaining wetland through an underground culvert (not annotated) at Churchman Avenue.

In this year's photographs recent precipitation is apparent. In the northern portion of the site possible liquid or staining is visible. In the northwestern portion of the site the horizontal tank and the light-toned mounded material and debris remain. In the eastern portion of the site one of the two areas of liquid seen in parking areas in 1997 remains. Only one of the probable vertical tanks previously seen near the south central portion of the site remains. The probable stain or liquid seen near the south central portion of the site is no longer visible. In the southeast corner of the site the holding pond with liquid remains. Immediately southeast of the Refined Metals Corporation, near a parking area, a probable pipe is visible. The domed structure remains visible in the open storage area located in the south central portion of the site.
